JOINTING PROCEDURES

VJRICE
 CONCRETE LIMITED
 Specialist in concrete products.

FOR "O"RING GASKETED PIPE.

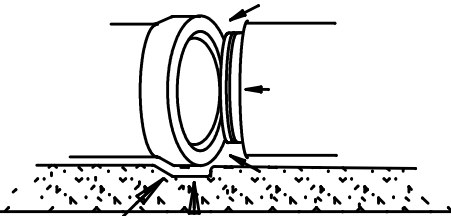
EQUALIZE STRETCH

INSERT A SMOOTH OBJECT, SUCH AS A SCREWDRIVER, UNDER THE GASKET AND RUN IT AROUND THE CIRCUMFERENCE TWO OR THREE TIMES. THIS EQUALIZES THE STRETCH IN THE GASKET AND IS VERY IMPORTANT WITH LARGER PIPE.

FAILURE TO EQUALIZE THE STRETCH OF THE GASKET CAN BE A CAUSE FOR LEAKS IN THE JOINT OR FOR THE GASKET TO BREAK.

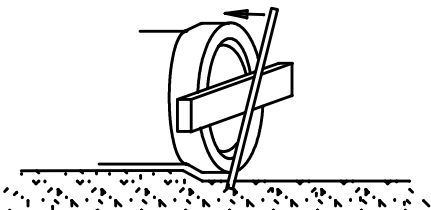
ALIGN CAREFULLY

WHEN COUPLING PIPE, ALIGN SPIGOT OF PIPE WITH BELL OF PIPE PREVIOUSLY LAID. PIPE SHOULD BE ALIGNED SO THAT THE GASKET IS IN CONTACT WITH THE FLARED BELL SURFACE AROUND THE ENTIRE CIRCUMFERENCE.

IF BELL AND SPIGOT ARE NOT LEVEL OR CAREFULLY ALIGNED, THE GASKET WILL FISH MOUTH, CAUSING A LEAK OR SPLITTING THE BELL.
